8. Conclusions

8.1 Comparison of Sites Grouped by Road Controlling Authority

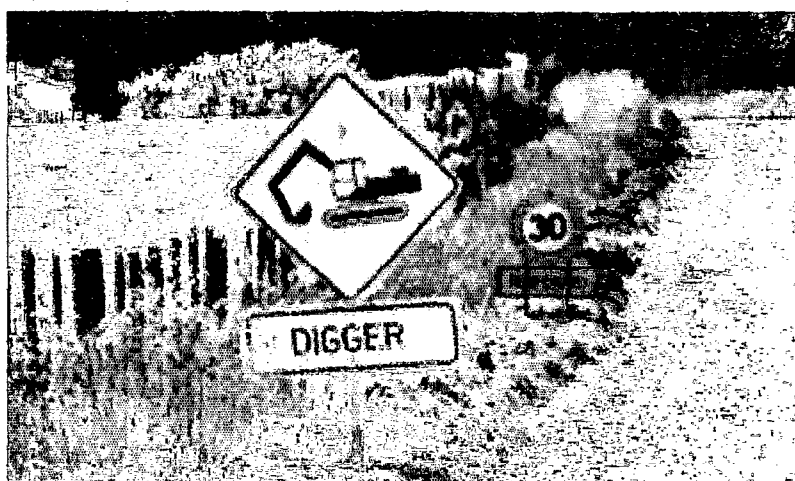
The use of 'non gazetted' signs means that in a legal sense there is no 'message' being legally conveyed to the road user where one of these signs is used. Similarly a court of law cannot recognise these signs. The purpose of using a regulated series and arrangement of signs is twofold:

Non gazetted 'Digger' sign

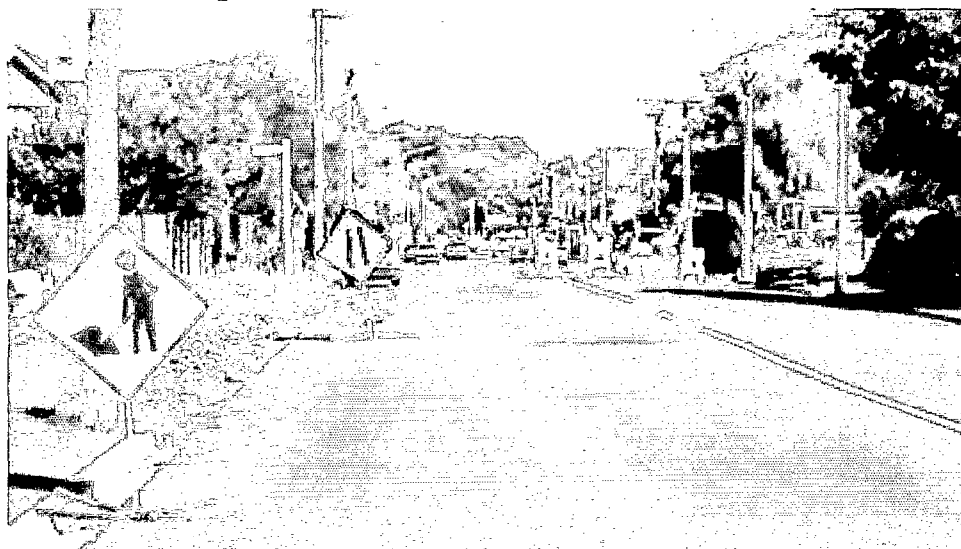
8.2.4.9 Lack of use of RG 19 and 20 (single lane priority signs) where TW 27 (road narrows) signs and uncontrolled single lanes had been implemented.

Single lane operation without traffic prioritising signs. 'Road Narrows' sign also shows wrong side narrowing.

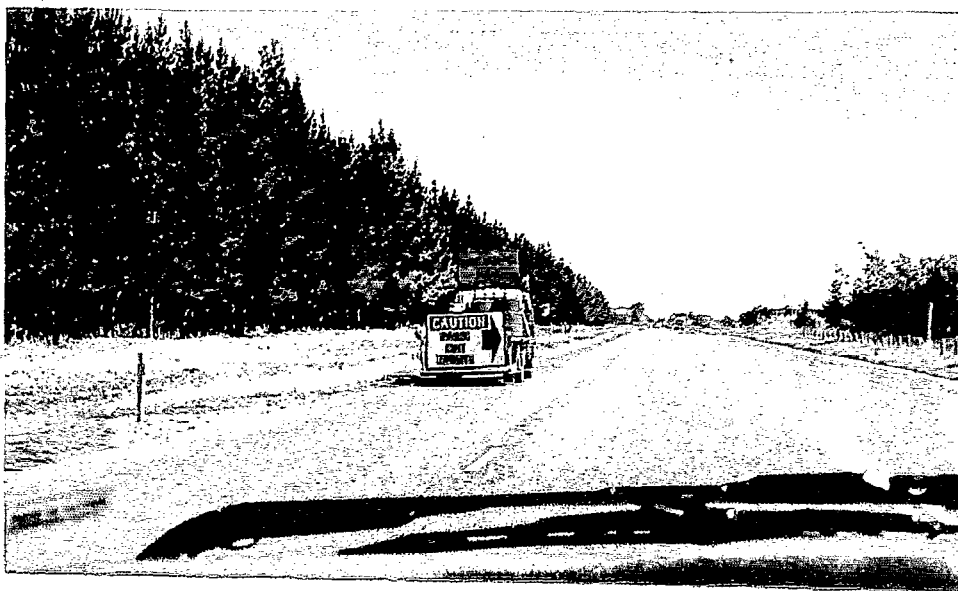
The two mobile closures encountered (Site 12 South Island and Site 12 North Island) also raise a significant issue. Whilst there are undoubtedly areas where the Contractors could improve the operation, the author is of the opinion that the overriding problem is one of a lack of sufficient and suitable standards to cover these works. This is demonstrated by the entirely different equipment used by the two contractors to guide and assist road users past their operations.

Example of mobile closure observed during South Island survey

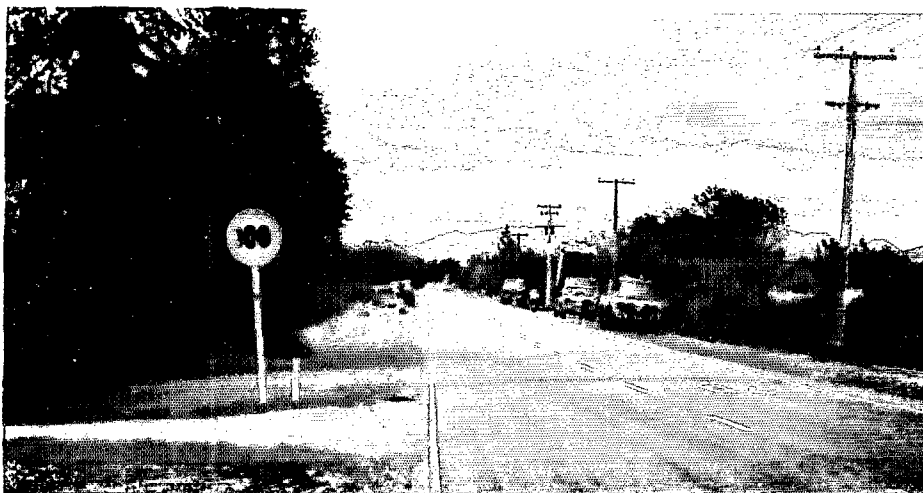
Of the 28 sites inspected in the North Island, 6 had no signs of any kind whilst a further 14 sites were missing signs in areas other than side roads and speed restrictions which are dealt with elsewhere.

Of the 31 sites inspected in the South Island, 5 had no signs of any kind whilst a further 18 sites were missing signs in areas other than side roads and speed restrictions.

Road works site operating without any signs

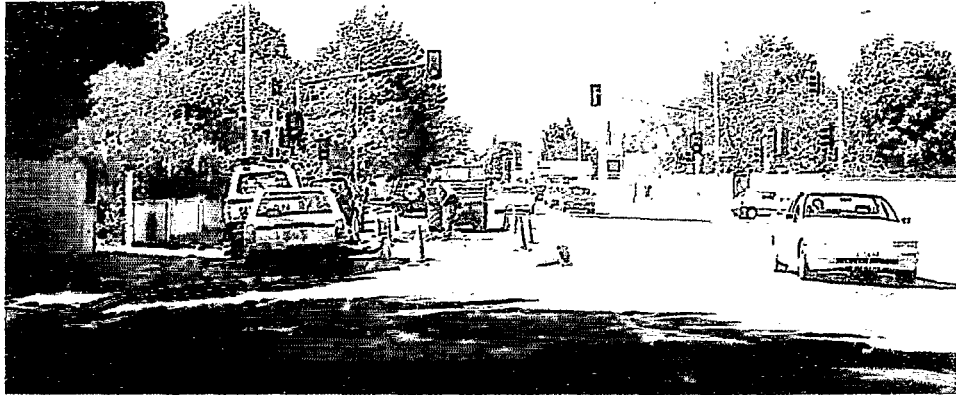
8.2.5.2 Cone tapers either non existent or too short

Example of closure with no approach taper

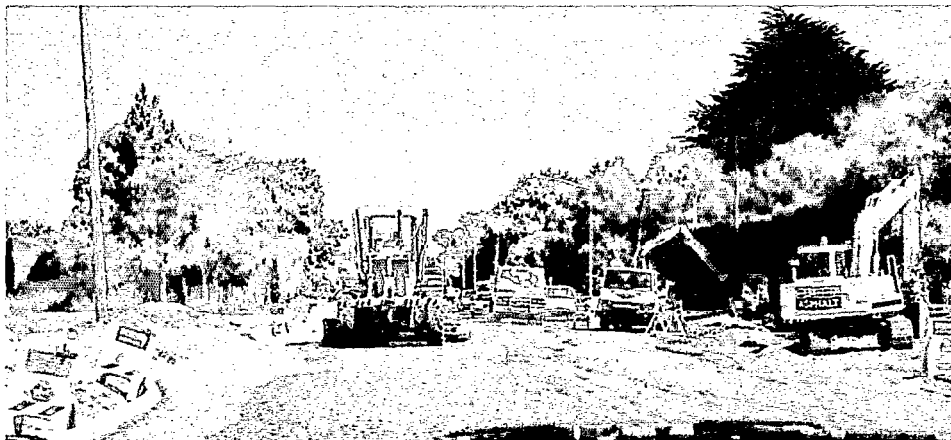
8.2.5.3 Edge and lane delineation at best poor where it was required

Example of site with no edge delineation or channelising of lanes

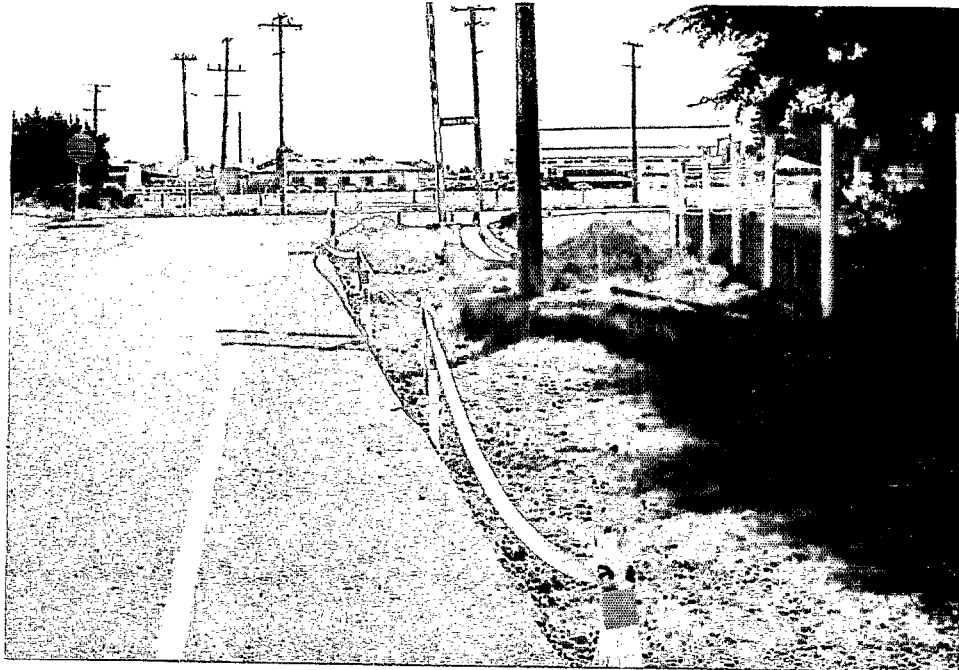
Particular note was made of the practice of using edge marker posts to delineate the side of the available road especially where there were significant hazards such as vertical drops (including one vertical drop in excess of 1 metre). Furthermore in the North Island survey it was noted that these had also been modified by casting them into concrete feet (no doubt to increase their stability without the need to drive them into the ground) without any apparent regard to the increased hazard resulting if they were struck by a road user.

Example of inappropriate use of marker posts to delineate edge of site. Also note the lack of safety zone and vertical drop immediately adjacent to the live lane

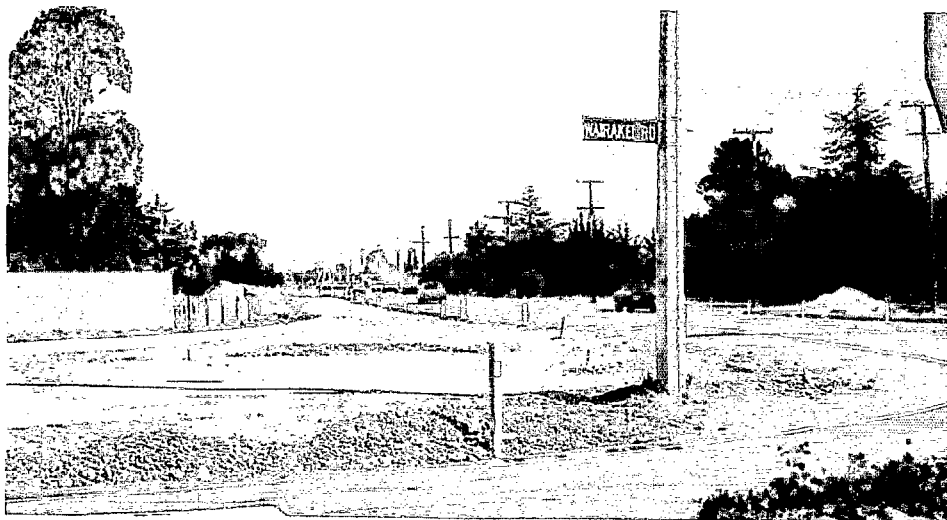
Spacing of the devices, where any were present, was generally inadequate with spacings of up to 100 metres being frequently noted.

Example of inappropriate use of edge marker posts and inadequate spacing of devices

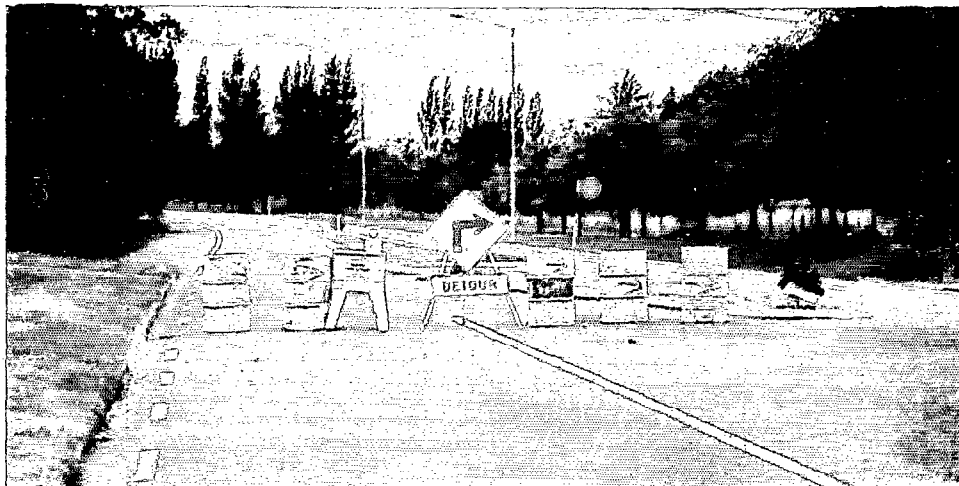
44 gallon steel drums were much in evidence in both surveys despite their well publicised banning by Transit New Zealand a number of years ago.

Example of a road closure using steel 44 gallon drums without a 'road closed' sign

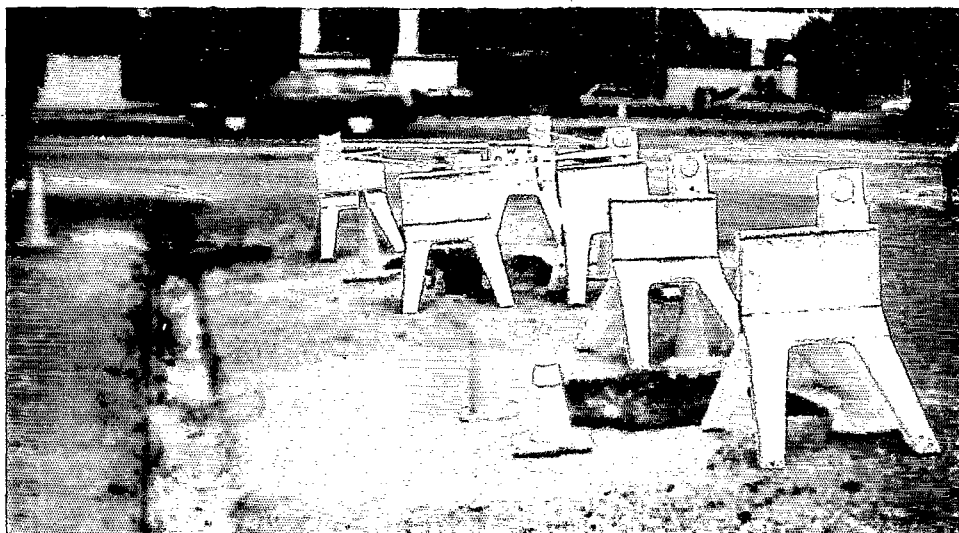
The non compliance with this requirement was also extensive with plant noted being operated in live lanes, materials stockpiled in or adjacent to live lanes and excavations left hard against live lanes. NB a live lane is defined as any lane which is designated for the use of road users at the time of the road works activity.

Example of site with no safety zone

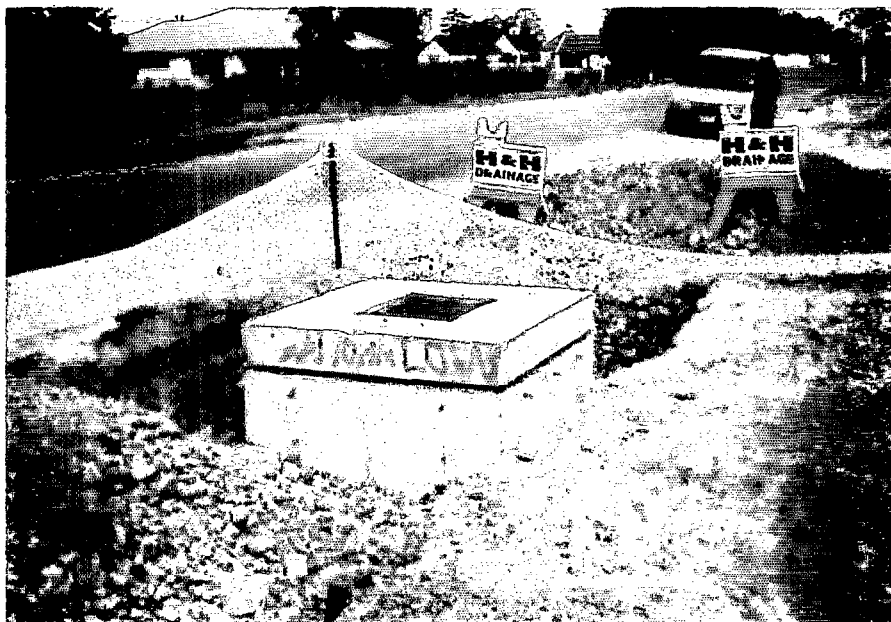
This was an area which considerable concern on both surveys with extensive drops (of over 1 metre in some cases) being noted with limited protection, delineation or safety zones being provided.

Inadequately delineated and protected unattended excavation

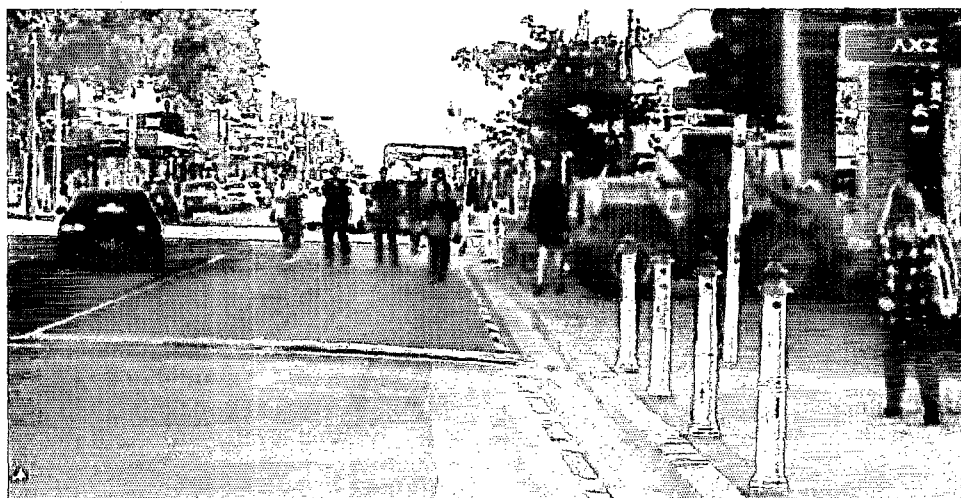
Where sites were located in urban areas with footpaths and these were affected by the works there was not one site which attempted to provide a secure clearly delineated alternative route. In many cases pedestrians were expected to walk in live lanes to pass the site.

Pedestrians forced to walk in a busy city street without protection because of roadworks on the adjoining footpath

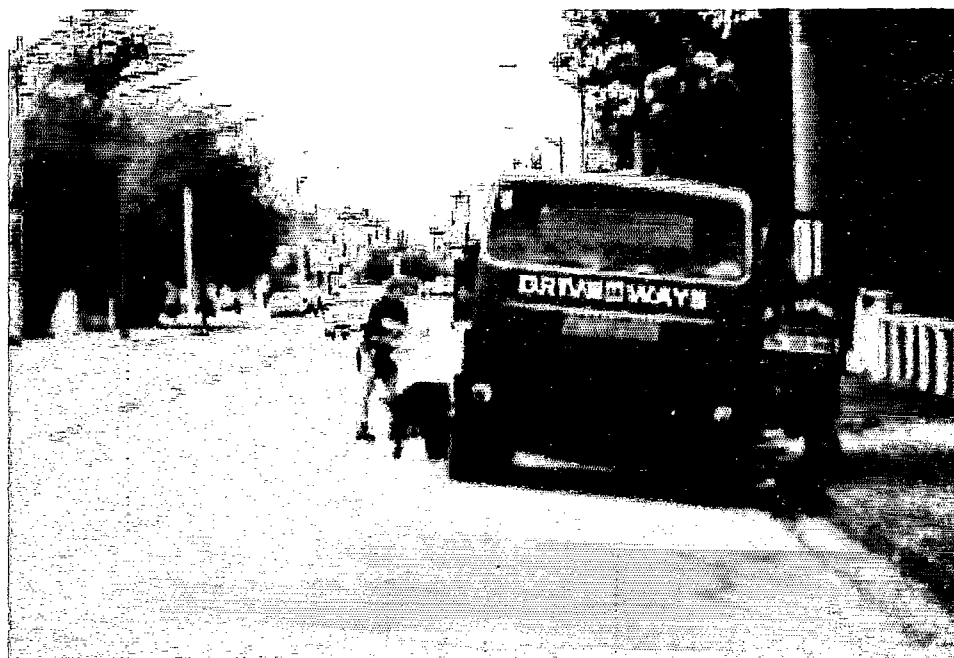
This is one area where the two surveys differed significantly. The South Island survey found that a significant number of workers were not wearing any form of high visibility clothing and some which were being worn were in poor condition. In the North Island this was not noted as a problem rather the reverse where only two personnel were noted without the appropriate high visibility garments.

Worker on road without high visibility jacket
